# Moisture Free Inspection Report

123 Our Street  
ThisTown, USA 12345

# Home & Stucco Inspections of Georgia

## Moisture Inspection Summary

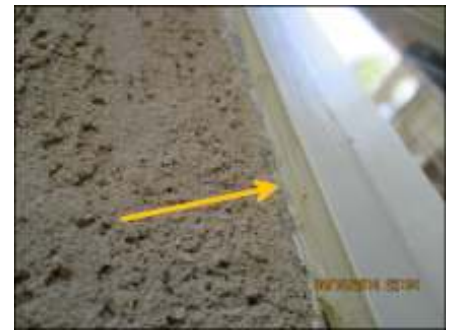
Good sealants around all window perimeters...good.

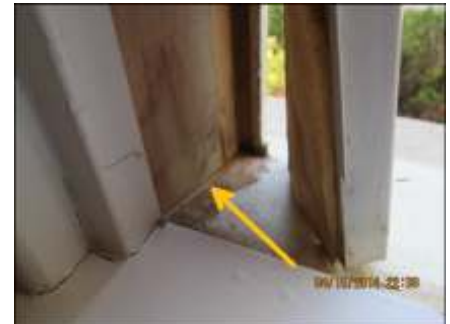
View behind UNSEALED window tracks. Moisture below.

**Caulk or re-caulk all doors and windows. For single or double hung windows, seal the tracks on all vertical joints from the head of the window to the sill and along the bottom joint of the track to the sill and at least 6” up the vertical joints behind the track. For casement windows, caulk or re-caulk all exposed joints, including the miter joints of the window. Chapter 2 and Chapter 4, Sections 2 & 4**

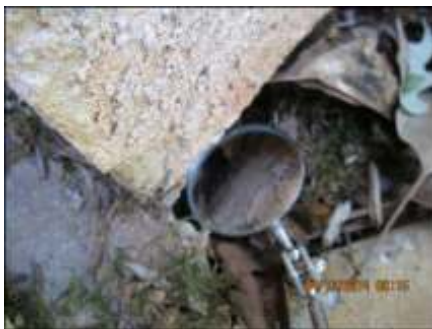
Mirror shows stucco foam is sealed at bottom

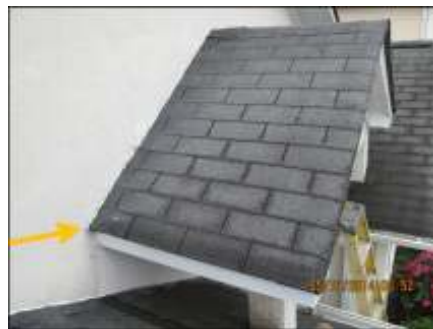
Missing kickout flashing has resulted in moisture intrusion

Kickout flashing should be installed at the location(s) indicated in this report. Chapter 2 and Chapter 4, Section 3

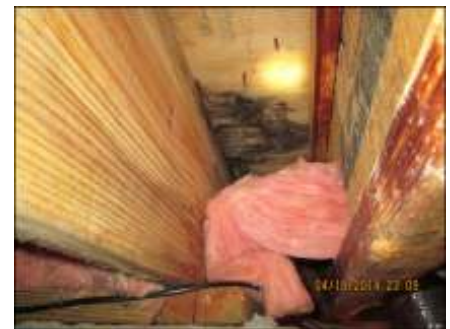
Attic view of moisture damage from improper kick-out flashing
