MoistureCheck

Stucco & Mold Inspections

ROOF SYSTEM - ATTIC

ROOFING:

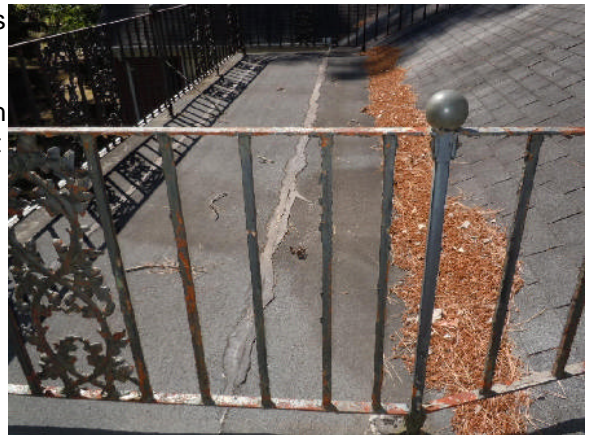
Flat roof on front porch appears to be serviceable at time of inspection: However, the asphalt based roll roofing which is currently installed should last a few more years. When replacement becomes necessary, I recommend using a rubberized bitimum type roll roofing, which will last many years.

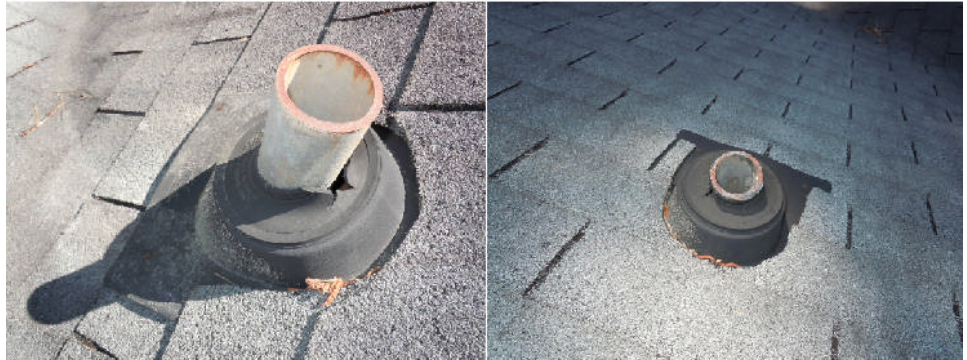
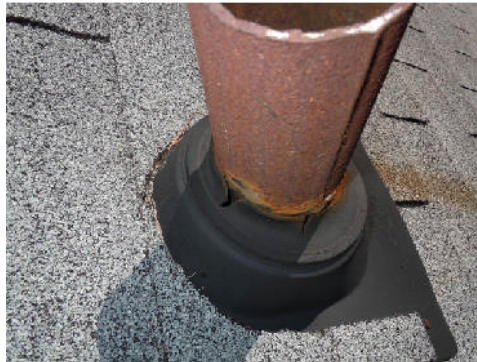
**PLUMBING
BOOT(S)
GENERAL
CONDITION:**

Front boots are cracked, 3 in all. Recommend replacing boots at earliest convenience, as a precaution against moisture intrusion.

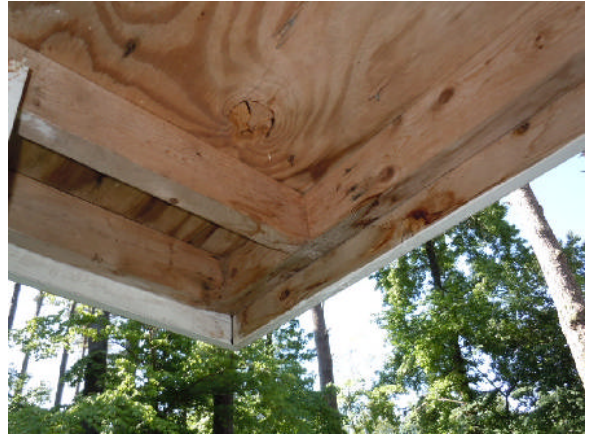
Back porch roof at basement area is low sloping and is shingled, which may be leaking, based on moisture stains noted on shed roof framing lumber and trim. Monitor this condition and consult with a roofer for recommendations if needed.

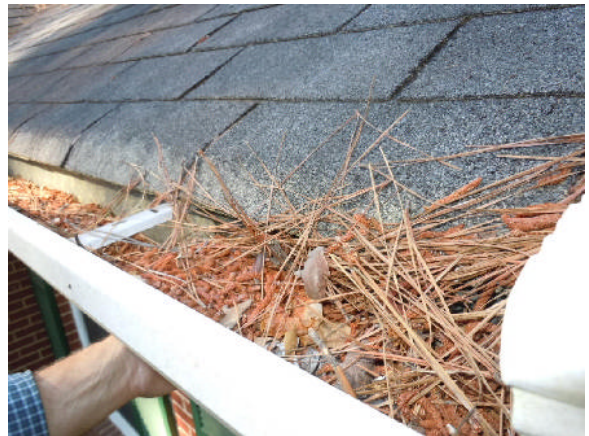
Gutters are full of debris. Recommend maintenance.
