**Smith**  
**123 Sample St.**  
**Anytown GA 30602**

**MoistureCheck**  
**Stucco & Mold Inspections**  
**4255 Old Danielsville Rd. Athens, GA 30601**  
 Athens: (706) 248-3596 Valdosta: (229) 269-0946  
 www.MoistureCheck.com Inspectorman2003@aol.com

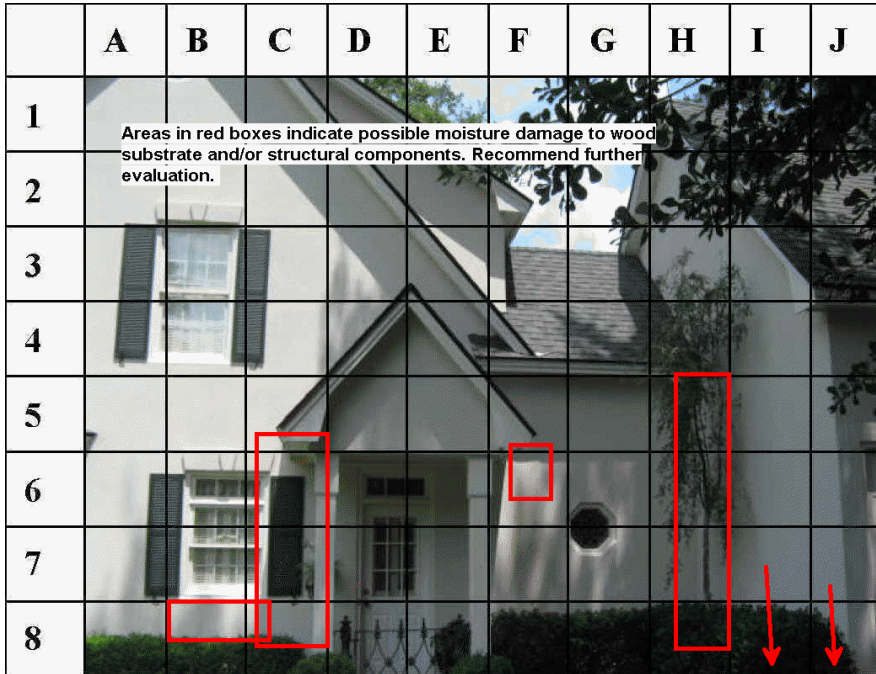
Areas in red boxes indicate possible moisture damage to wood substrate and/or structural components. Recommend further evaluation.

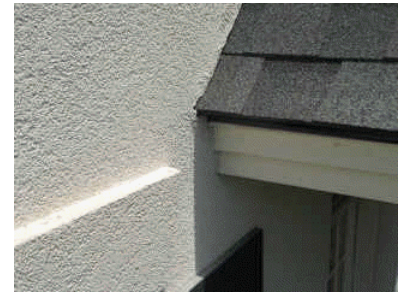
C5: Missing kickout flashing

Grid Location	Item Description	Moisture Readings	Substrate Condition	Observations
B8,C8	Window	40%40%	semisoft	Elevated moisture readings below window. Moisture may be window and/or spigot related from recent leak.
C5,C8	Kickout area	40%40%	soft	Missing kickout flashing with possible substrate damage below.
F6,F7	Kickout area	40%18%	semisoft	Missing kickout flashing with elevated moisture below and possible substrate damage where indicated.
H5,H6	Kickout area	40%40%	soft	Missing kickout flashing with possible substrate damage below.
H8-J8	Buried foam	Inaccessible	not probed	Shrubbery prevented access, but foam appears to be buried. Modifications are recommended to ensure foam is above grade and sealed along bottom edge.

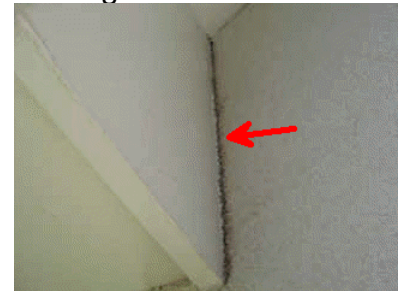
Dissembler material joints need to be caulked

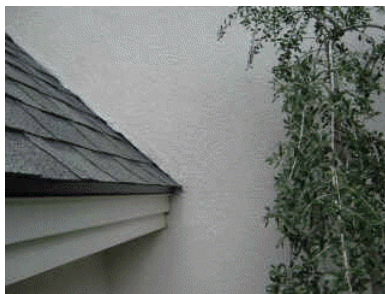
H4: Missing kickout flashing

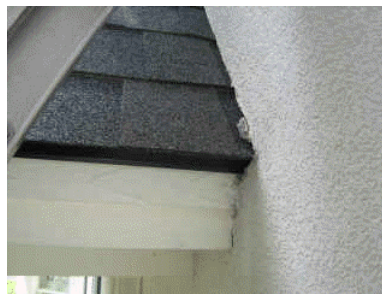
F5: Missing kickout flashing

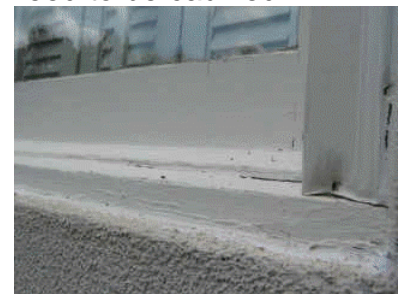
B7: Window components have moisture rot
